Soil Report for the 2013 Mountain Fire San Bernardino National Forest

Resource Specialty: Soil

Fire Name: Mountain, San Bernardino National Forest

Author(s) Name and Home Unit: Alex Janicki, Soil Scientist, Stanislaus N.F.
Curtis Kvamme, Soil Scientist, Stanislaus, N.F.

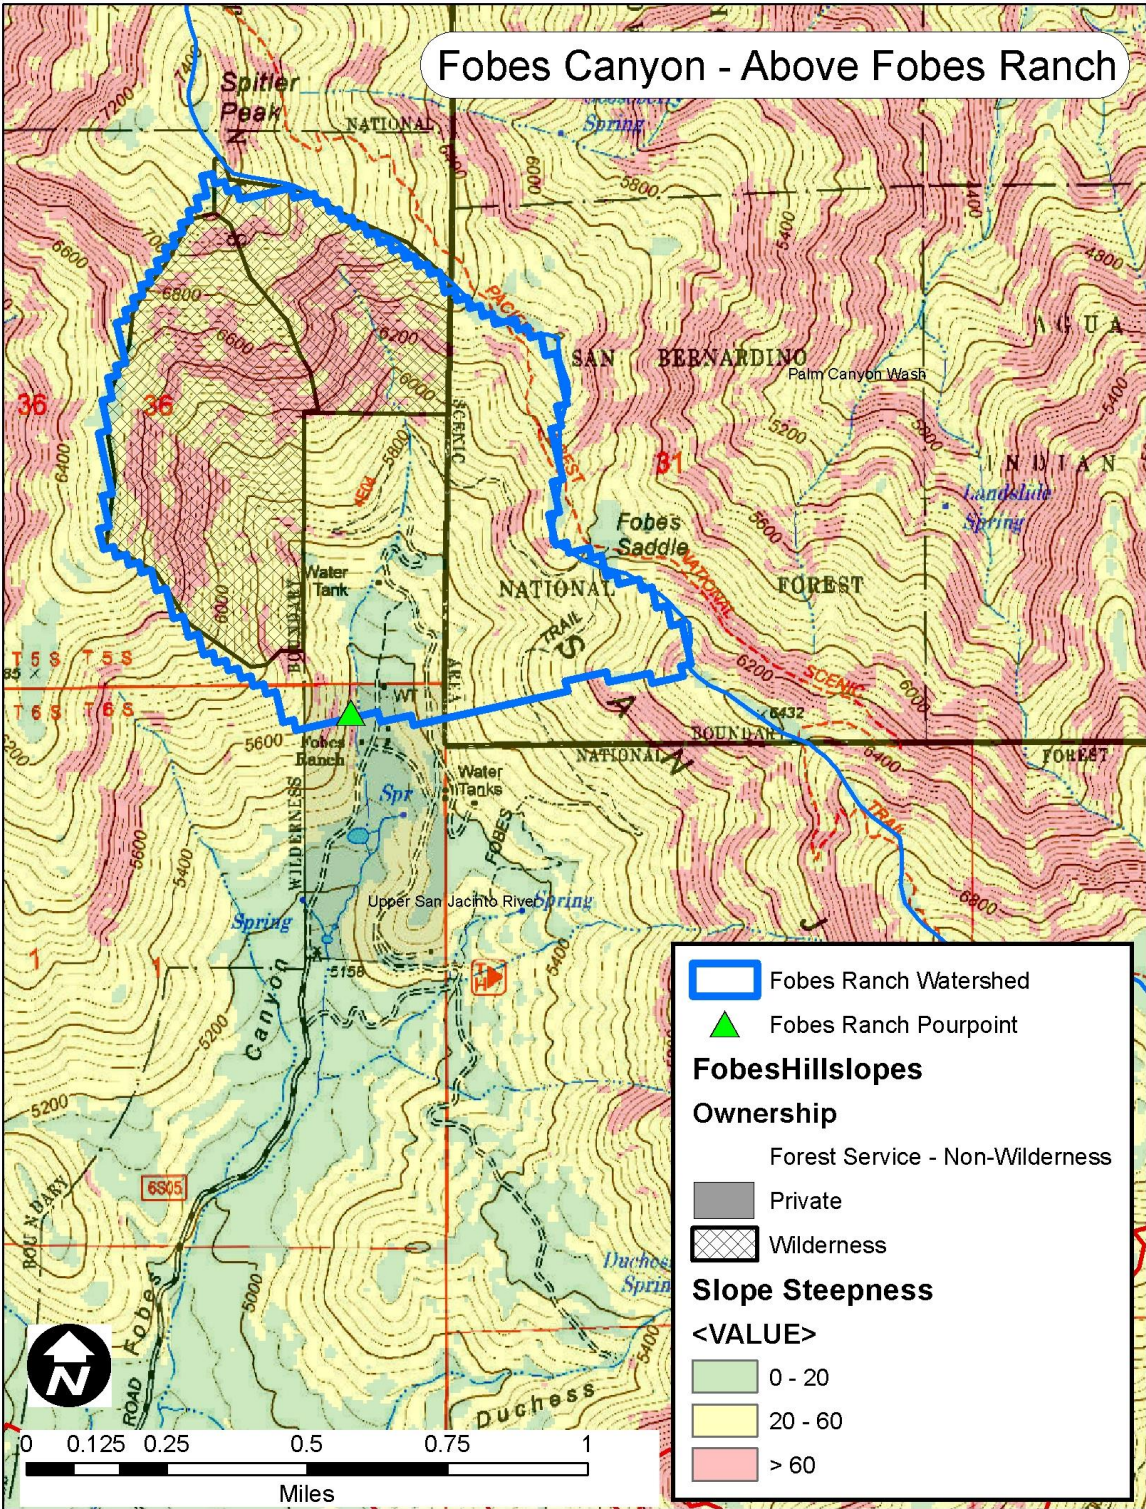
Figure 1 – Fobes Canyon

The Fobes Ranch property sits at the base of the steep upper slopes of Fobes canyon on an alluvial fan, and receives runoff in a nearby stream channel from a ~430 acre moderately burned watershed. Approximately 90% of the steep hillslopes above Fobes Ranch were mapped with moderate soil burn severity, removing a significant portion of protective ground cover and increasing erosion potential. Moderately hydrophobic soils were noted during field surveys; in intense rain events the hydrophobicity is strong enough in Fobes Canyon to cause rill initiation, but not strong enough to completely prevent water infiltration. Thus, intense rain events that exceed the infiltration capacity of the soil are the most likely to cause excessive rill erosion, which could contribute to a damaging mudflow. Because of the high critical value at Fobes Ranch, three separate erosion models were used to assess the risk level of sedimentation to streams. All three models (ERMiT, RCS, and AGWA) predict highly elevated erosion rates and sediment delivery to the pourpoint above the ranch house (Table 2). ERMiT predicts that erosion levels will remain elevated and will have the potential to contribute to damaging mudflows for at least 3 years. This predicted increase in runoff and sediment loading in Fobes Canyon, combined with the close proximity of buildings to the Fobes channel justifies an emergency determination.

Probability of damage or loss: Very Likely. Flooding and hyperconcentrated flows (mudflows) resulting from increased erosion are very likely to damage private structures at Fobes Ranch.

Magnitude of consequences: Major. The predicted size of runoff events and the amount of material that could be deposited at Fobes ranch could cause substantial property damage, and may threaten life and safety of humans.

Risk Level: Very High. The BAER team recommends a point treatment on private land to directly protect life, safety, and property at Fobes Ranch. We believe treatments on private land in close proximity to structures at risk of flooding and sediment deposition would be more effective than a land treatment on Forest Service land. A discussion of why land treatments are not recommended in Fobes canyon is given below in the “Treatments to Mitigate the Emergency” section.

Because of the high risk of increased sedimentation in Fobes Canyon above the Ranch house, ERMiT was used to predict the potential effectiveness of a land treatment – spreading wood straw or mulch – to reduce sedimentation rates and peak flows. Figure 1 shows the sub-watershed that flows into the pourpoint above Fobes Ranch (in blue). The crosshatched area is designated as wilderness, and the red areas are slopes >60%. These areas represent ground that is not feasible to treat with mulch or wood straw. If eliminated, results from ERMiT show that only a 30% reduction in sediment production would be achieved by treating non-wilderness Forest Service ground that is <60% slope. If a treatment were done, this reduction in sediment would not be sufficient to reduce the risk of sedimentation and damaging mudflows.

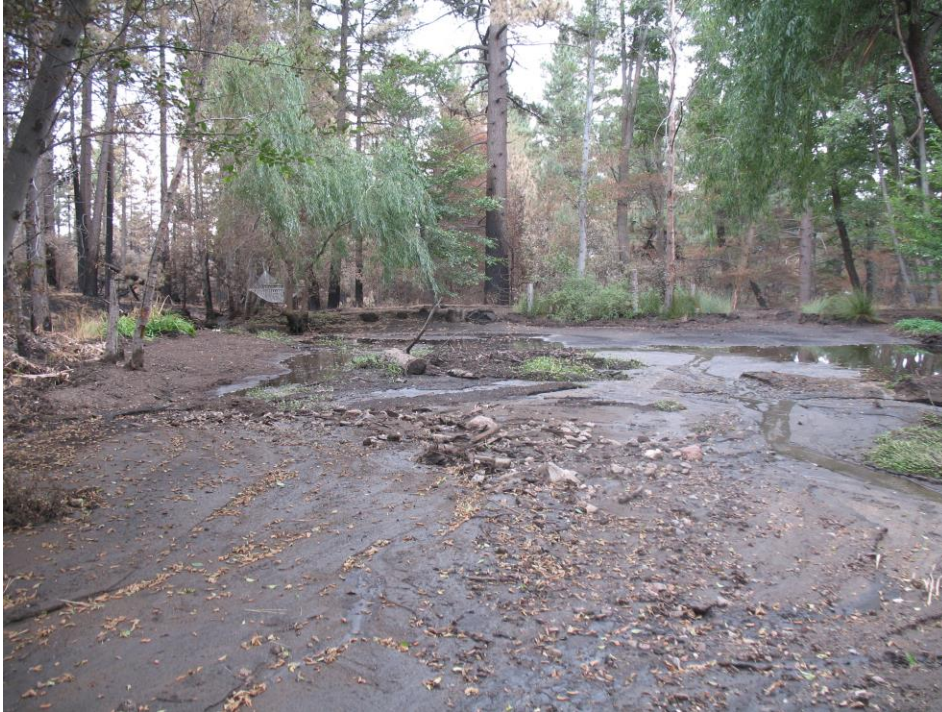
Two critical values in Apple Canyon below the Zen Center were assessed for risk of flooding, increased sedimentation, and property damage to houses and constructed dams. Constructed earthen dams at both the Apple Canyon Ranch (one dam) and at Bonita Vista Ranch (two dams) received significant sediment inputs from hyperconcentrated mudflows occurring in late July, 2013. The dam at Apple Canyon Ranch, which is upstream from Bonita Vista Ranch, was completely filled in with sediment and was overtopped by a mudflow. Additionally, water seepage was noted coming from the bottom of the dam. The existing condition of these dams, and the risk of future storms producing additional sediment delivery and high flows justifies an emergency determination at both locations. See Appendix C.

Probability of Damage or Loss: Likely. Damage or loss of the dam at Apple Canyon Ranch is likely due to the modeling data indicating a high probability of additional flood events with high peak flows.

Magnitude of Consequences: Moderate. Property damage would include potential dam failure, and resulting impacts to structures that are approximately .5 miles downstream from this dam (at Bonita Vista Ranch).

Dam at Apple Canyon Ranch –Pond behind dam filled in with sediment & was overtopped by a hyperconcentrated mudflow.

Risk Level: High. The BAER team recommends that the structural stability of the dam at Apple Canyon Ranch be assessed by a geotechnical or other appropriate engineer familiar with earthen dams. The risk of dam failure is closely tied to the risk level the team assigned to Bonita Vista Ranch.

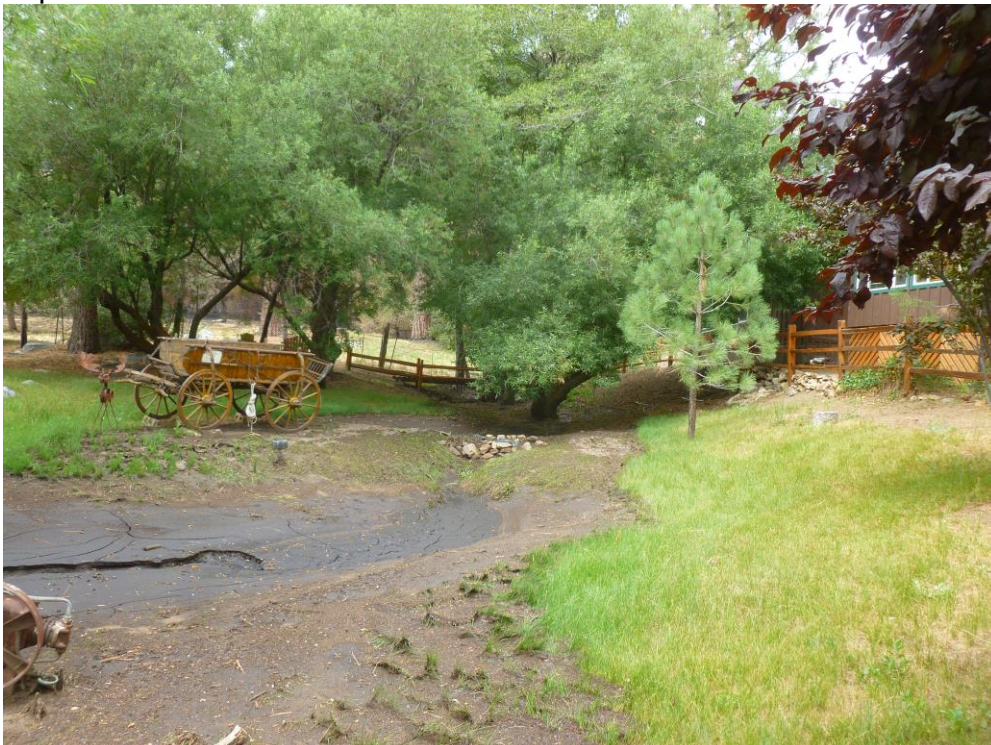
Probability of Damage or Loss: Very Likely. Flooding and hyper-concentrated flows (mudflows) resulting from increased erosion are very likely to damage private structures at Bonita Vista Ranch. Possible dam failure upstream at Apple Canyon Ranch would significantly increase the probability of property damage, and was considered in our rating of very likely.

Magnitude of Consequences: Major. The predicted size of runoff events and the amount of material that could be deposited at Fobes ranch could cause substantial property damage, and may threaten life or injury to humans.

Structure adjacent to stream at Bonita Vista Ranch (in Apple Canyon), and sediment deposited in stream.

Risk Level: Very High. The BAER team recommends a point treatment on private land to directly protect life and property at Bonita Vista Ranch. We believe treatments on private land in close proximity to structures at risk of flooding and sediment deposition would be more effective than a land treatment on Forest Service land. A discussion of why land treatments are not recommended is given below in "Treatments to Mitigate the Emergency."
